ZIRCONIA

Tips & Tricks

with Paul Cascone, BE MetE, MS

Zirconia Fracturing

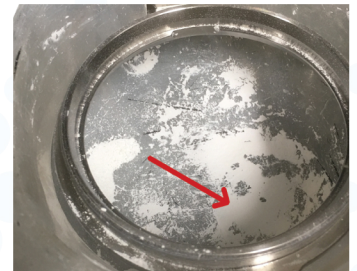
2) The inside of the top holder also should be cleaned to ensure the screw threads operate properly. Please take notice of the grommet on the inside of the top ring holder. This grommet presses on the disc so that the pressure is uniformly applied. If the opposite side has not been cleaned, there will be pressure points on portions of the disc where the residual zirconia powder was left. The pressure points may create fine fractures in the disc.

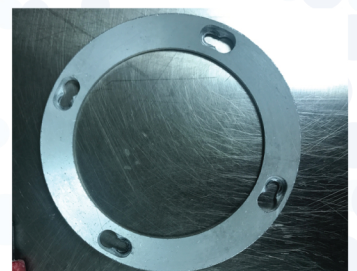
4) Avoid over-tightening the disc in the machine as excessive pressure will create fractures.

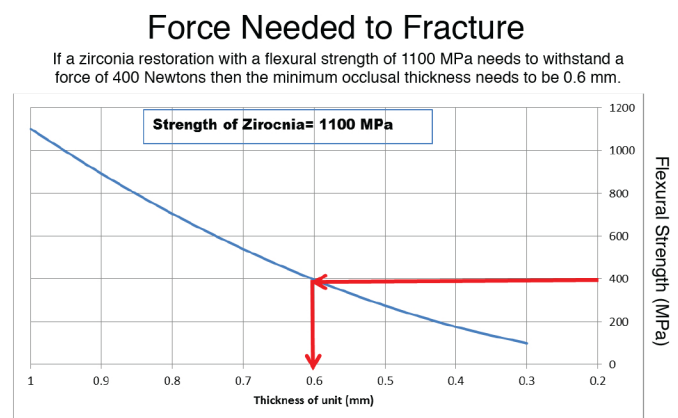
Figure 2

For example, as demonstrated in Figure 2, if a zirconia restoration with a flexural strength of 1100 MPa needs to withstand a force of 400 Newtons, then the minimum occlusal thickness needs to be 0.6 mm. In short, the preparation design must accommodate the strength of zirconia used.
