# ZIRCONIA

## *Tips & Tricks*

## Preventing Zirconia Fractures

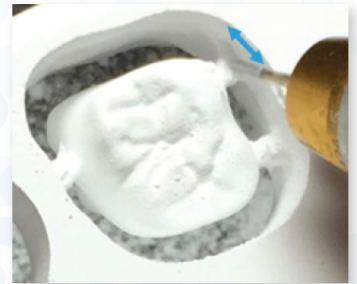
- 4) When cutting the last support, ensure that the zirconia unit does not fall through onto a hard surface. Damage to the margin or the walls of the units will result.
